# NATIONAL TRANSPORTATION SAFETY BOARD

## AIRCRAFT ACCIDENT REPORT

RUNWAY OVERRUN DURING LANDING  
AMERICAN AIRLINES FLIGHT 1420  
MCDONNELL DOUGLAS MD-82, N215AA  
LITTLE ROCK, ARKANSAS  
JUNE 1, 1999

**NTSB/AAR-01/02  
PB2001-910402  
Notation 7195A  
Adopted October 23, 2001**

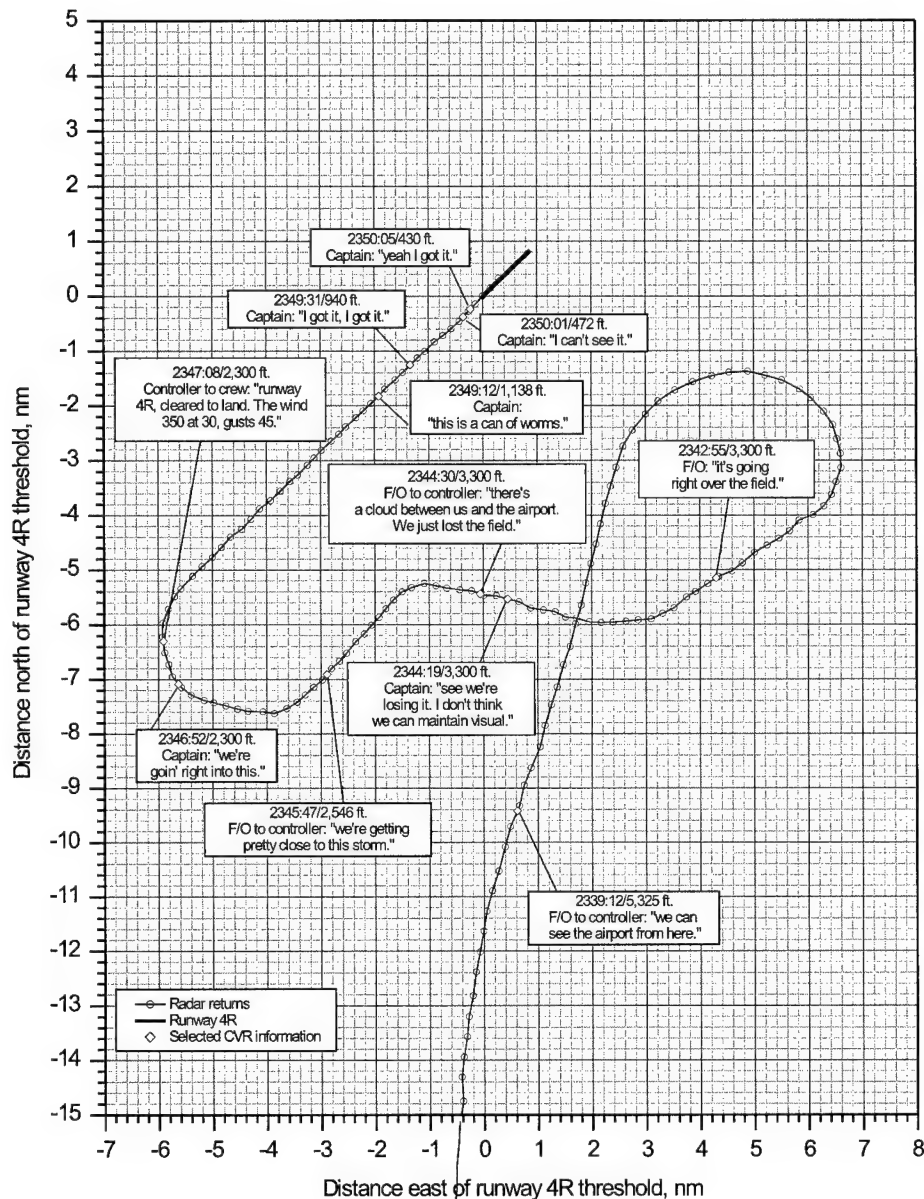
**Figure 1.** Flight 1420's Approach Path to the Airport and Key CVR Comments

The CVR indicated that, at 2350:00, the first officer said, "we're way off." Flight data recorder (FDR) information indicated that the localizer deviation value was about one dot to the right at that point.<sup>18</sup> About 1 second later, the captain stated, "I can't see it." About 3 seconds afterward, the first officer asked, "got it?" to which the captain replied, "yeah I got it." At 2350:13 and :14, the CVR recorded the sound of the ground proximity warning system (GPWS) radio altitude callout "sink rate."<sup>19</sup> Calculations based on FDR data indicated that the airplane was descending through an altitude of about 70 feet afl at the time of the first sink rate warning and about 50 feet afl at the time of the second warning. Figure 1 shows flight 1420's flightpath to Little Rock and runway 4R along with key CVR comments and the airplane's location when the comments were made.

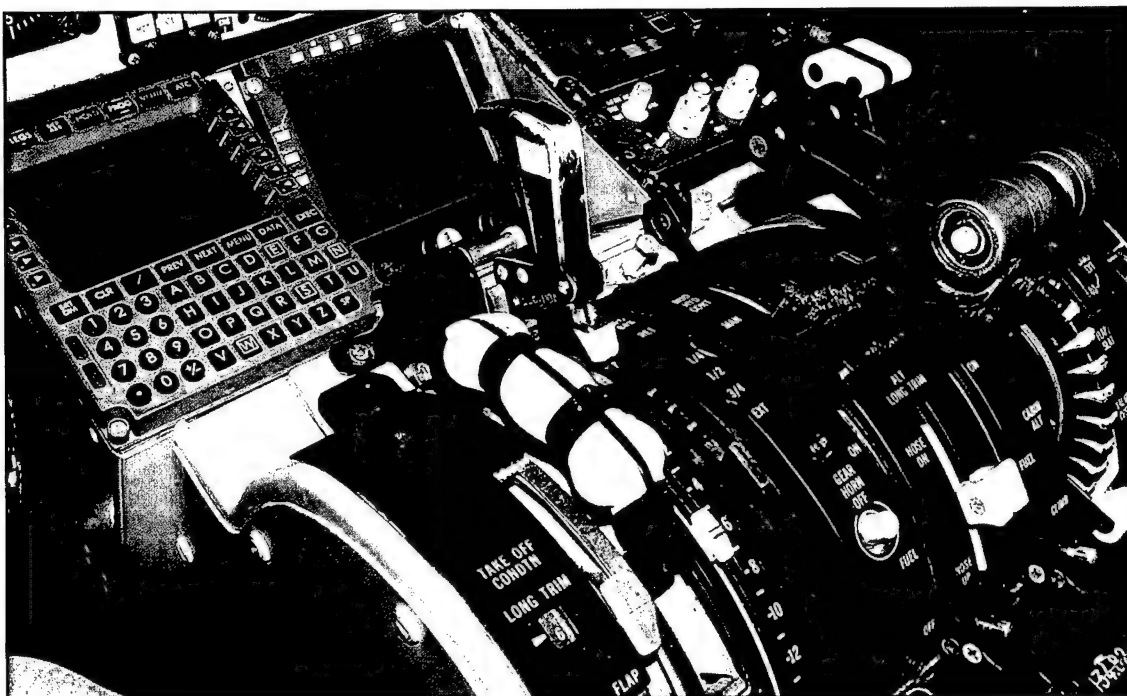
Figure 4. Spoiler Handle in the Unarmed Position

Figures 2 through 6 show the MD-80 spoiler system. Figure 2 shows the spoiler control system, including the locations of the flight and ground spoilers. Figure 3 shows the spoiler hydraulic system. Figures 4 and 5 are photographs showing the location of the spoiler handle in the unarmed and armed positions, respectively. Figure 6 shows the position of the crank arm and roller with the spoiler handle in unarmed and armed positions.

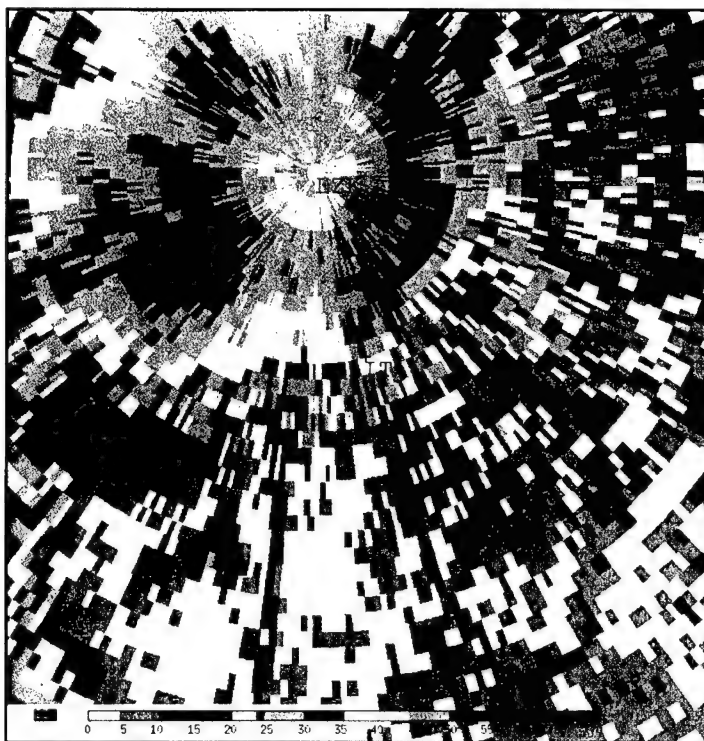
Figure 7. 0.4° Base Reflectivity Scan at 2334:27

The WSR-88D's base reflectivity images provided the radar reflectivities at the individual elevation scans. The images documented the line of thunderstorms moving across the Little Rock airport area during flight 1420's approach. The WSR-88D 0.4° elevation scan of base reflectivity that was completed at 2334:27 depicted reflectivities of 50 dBz, or NWS level 5 (intense) activity over the northwest section of the airport. By 2340:28, the 0.4° base reflectivity image depicted a large area of activity over the airport with reflectivities of 45 dBz, or level 4 (very strong) activity, and greater. The two strongest areas of activity were located approximately 5 miles west-northwest and northeast at this time. Another area of activity located approximately 3 miles southwest of Little Rock was beginning to move toward the east-southeast with reflectivities reaching 54 dBz, or level 6 (extreme) activity. Figures 7 and 8 show the base reflectivity products for 2334:27 and 2340:28, respectively.

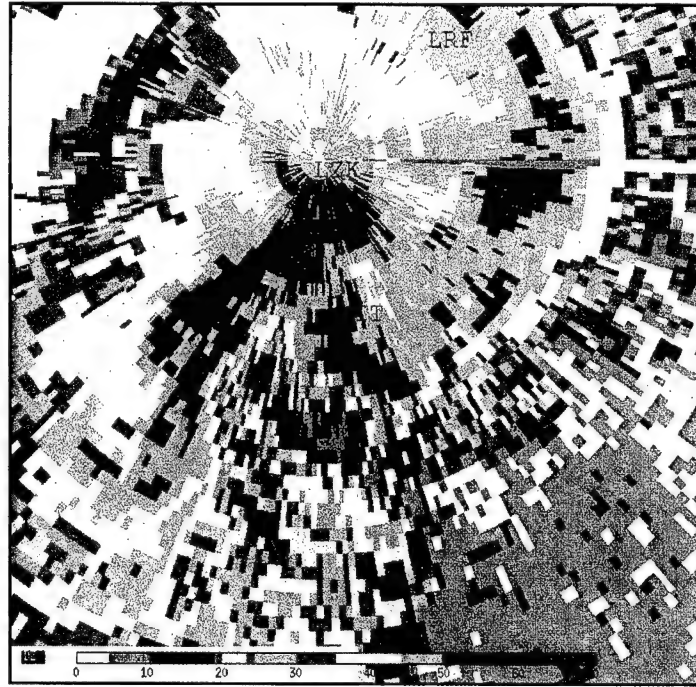
**Figure 9.** 0.4° Base Reflectivity Scan at 2345:57

The WSR-88D's 0.4° elevation scan of base reflectivity that was completed at 2345:57 indicated that the area over the airport and the approach end of runway 4R reached reflectivities of 54 dBz, or level 5 (intense) activity, and that the area approximately 5 miles west of runway 4R reached maximum reflectivities of 61.5 dBz, or level 6 (extreme) activity. Figure 9 shows the base reflectivity product for this time period.

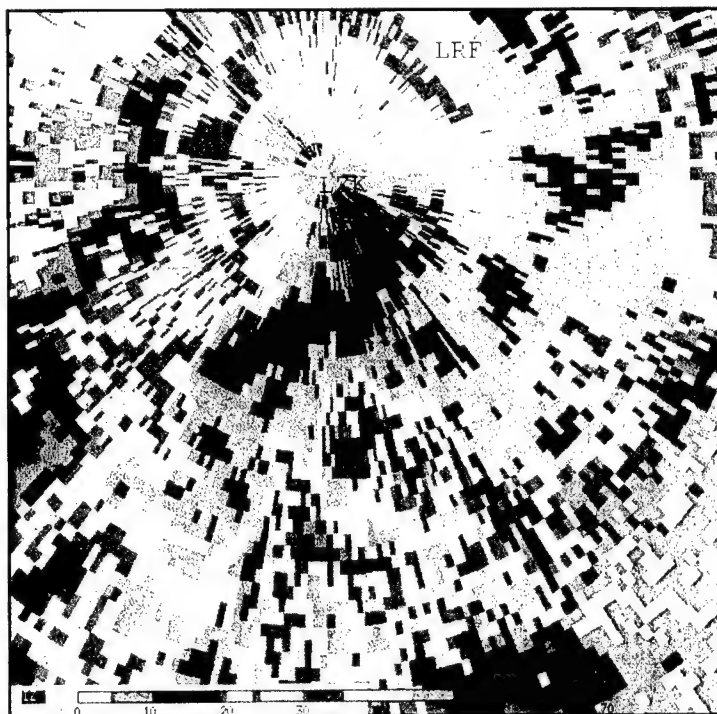
Figure 10. 0.4° Base Reflectivity Scan at 2351:59

At 2351:59, the 0.4° base reflectivity image depicted a maximum of 52 dBz, or level 5 (intense) activity, along the flight track, with maximum reflectivities of 60 dBz, or level 6 (extreme) activity, located 1 1/2 miles to the northwest. Figure 10 shows the base reflectivity product for this time period. Also, the 1.5° elevation scan at 2353:03 indicated returns of 58 dBz, or level 6 activity, with maximum reflectivities of 62.5 dBz 1/2 mile from the approach end of runway 4R.

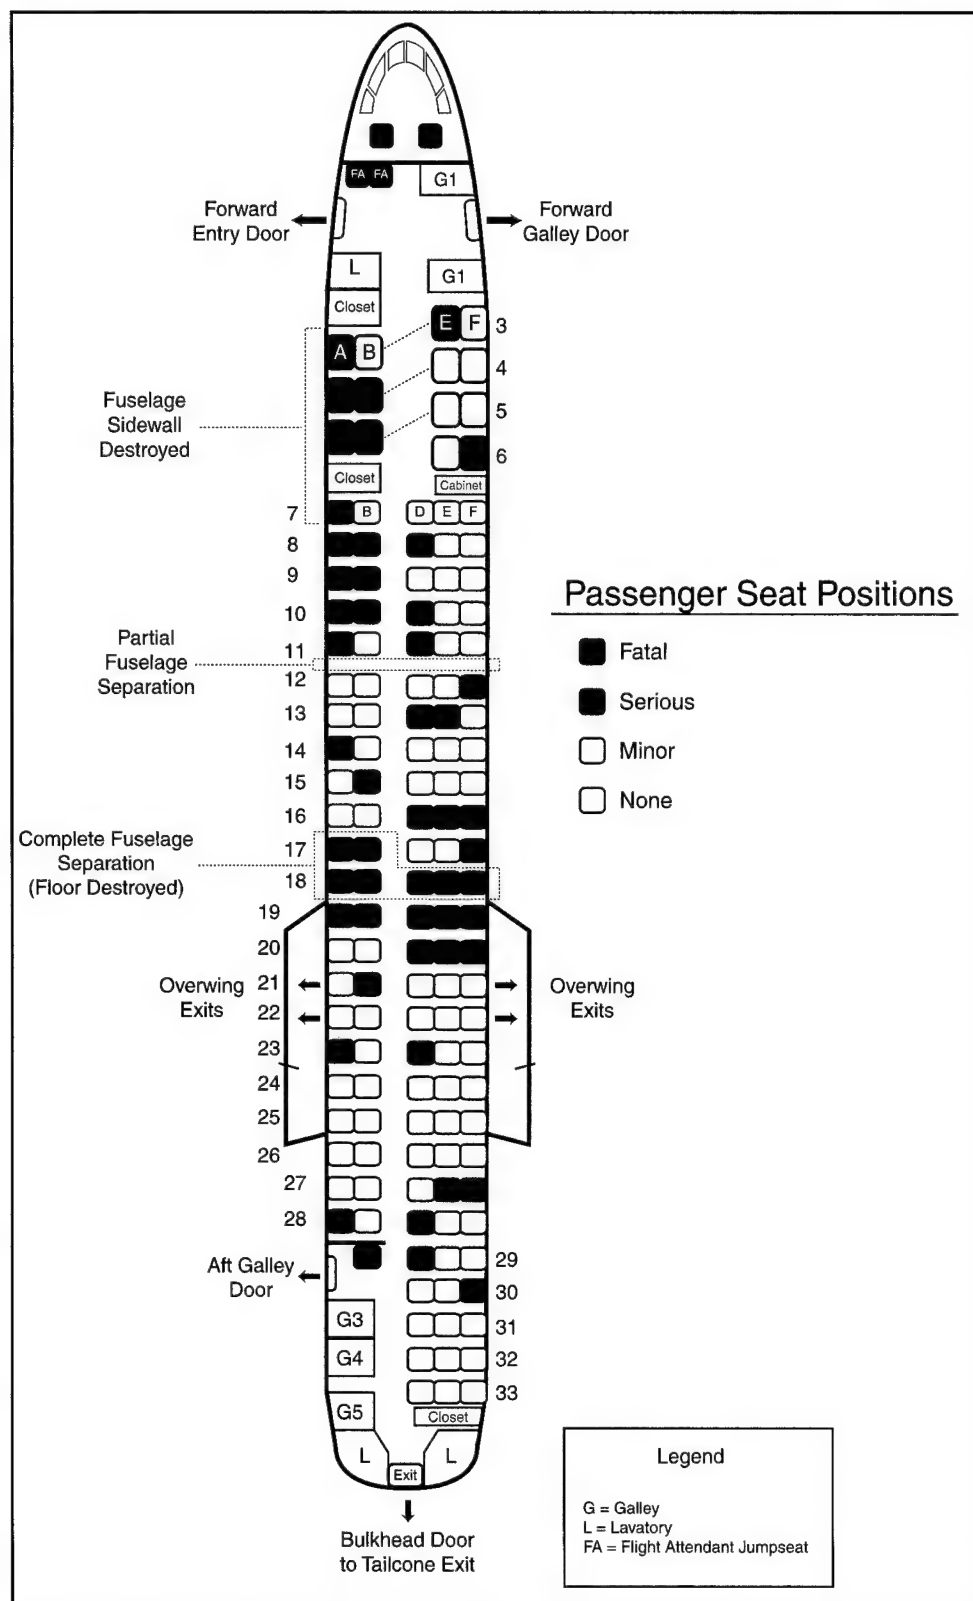
Figure 15. Interior Airplane Configuration and Occupant Injuries

The accident airplane's interior was original equipment installed in 1983. The airplane was configured with 139 passenger seats, 14 in first class and 125 in coach class. The cockpit contained two flight crew seats and one observer seat. An aft-facing, double-occupancy flight attendant jumpseat was located by the 1L exit door; an aft-facing, single-occupancy flight attendant jumpseat was located by the 2L exit door; and a forward-facing, double-occupancy flight attendant jumpseat was mounted on the tailcone exit door. Figure 15 shows the interior airplane configuration and the injuries sustained by the passengers and crewmembers according to seat location.

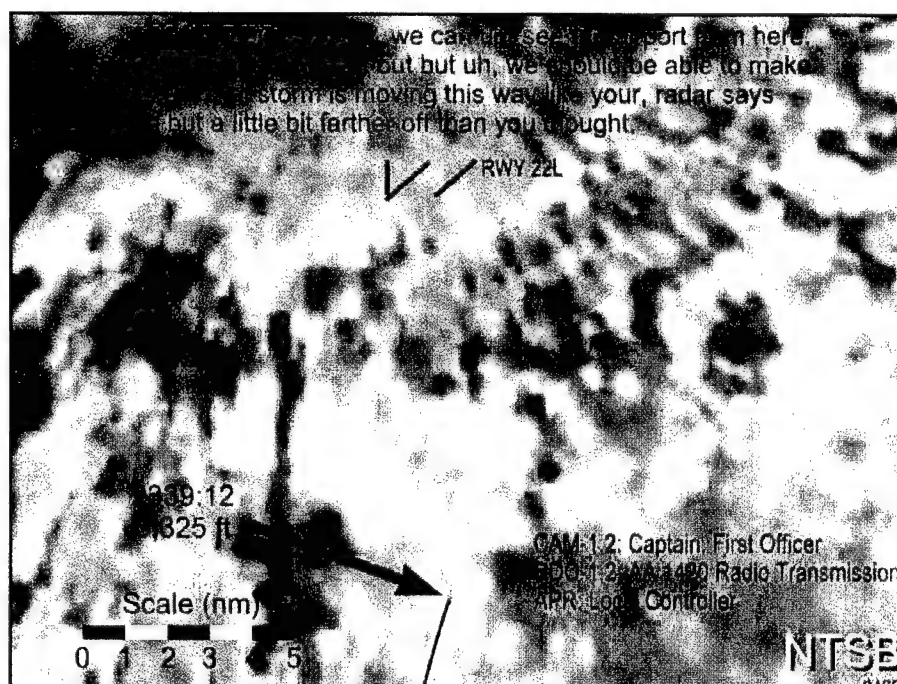
Figure 18. Weather and Flight Information for 2339:12

American’s policy did not prohibit flight crews from continuing an approach with thunderstorms in the terminal area as long as the crews ensured that their intended route was clear of the thunderstorms. During the descent into the terminal area, there was no evidence to indicate that the route was not clear. In public hearing testimony, the first officer stated that, during the descent, the weather was to the left and moving off to the right and that the airport looked clear. Thus, the Safety Board concludes that, during the

descent into the terminal area, the flight crewmembers could have reasonably believed that they could reach the airport before the thunderstorm.

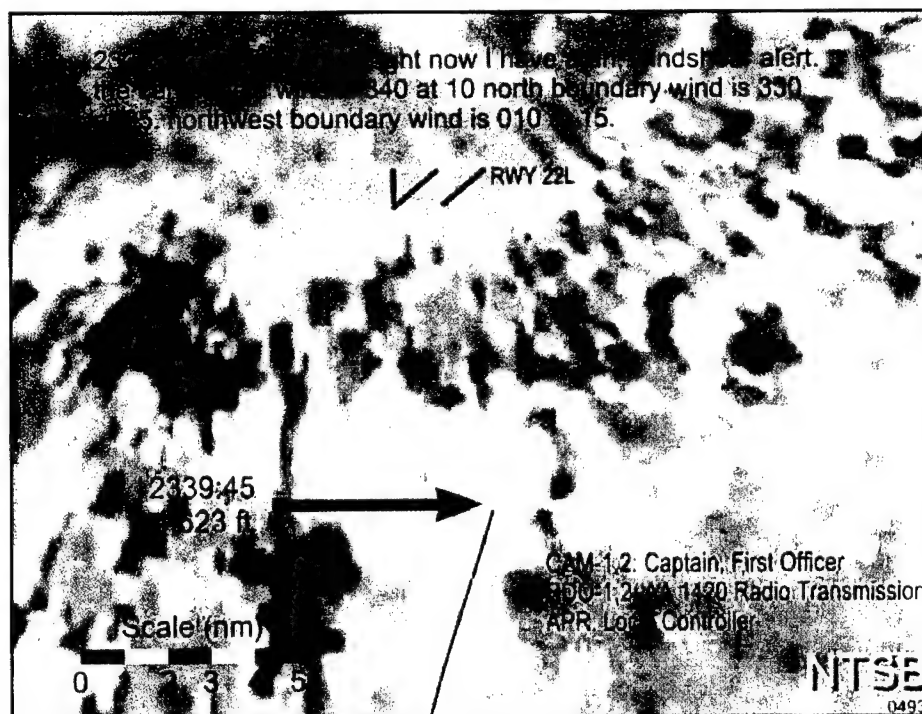
**Figure 19. Weather and Flight Information for 2339:45**

The flight crewmembers had been previously told by the controller to expect an instrument landing system (ILS) approach to runway 22L. At 2339:45, the local controller broadcast the first of two windshear alerts, reporting that the centerfield wind was 340° at 10 knots.<sup>178</sup> At this point, the airplane was about 8 miles from the airport. Afterward, the flight crew requested a change in runways from 22L to 4R because the winds had shifted to the northwest. The use of runway 22L could have resulted in a tailwind at the time of landing, so runway 4R was a more appropriate choice because of the expectation of a headwind. (NWS radar data indicated that the leading edge of a line of thunderstorms was over the airport at this time with the heaviest activity located northwest through northeast 5 miles from the runway.)<sup>179</sup> Figure 19 shows a map of the weather conditions at 2339:45 and flight 1420's location.

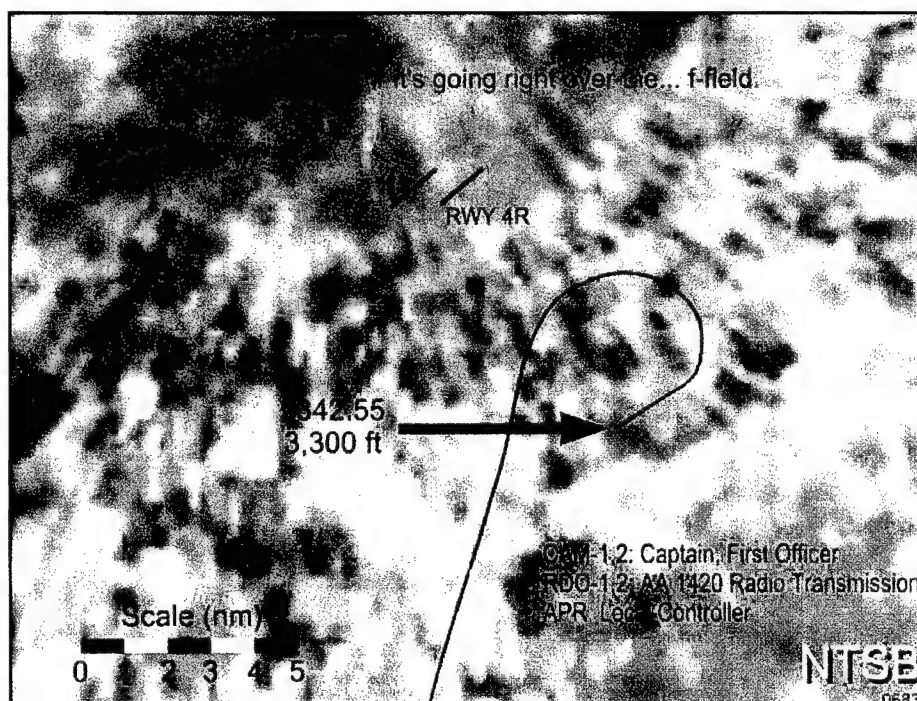
Figure 20. Weather and Flight Information for 2342:55

The flight crew continued to receive, but did not discuss, wind reports from the controller. The flight crew's actions and conversations during this phase of the approach largely consisted of steps to expedite the approach to the airport. For example, at 2342:40, the first officer asked the captain if he wanted to conduct a "short approach" and "keep it in tight." The captain accepted the suggestion but with the qualification "if you see the runway, 'cause I don't quite see it." (The airport was off the right, or first officer's, side of the airplane.) The first officer began to radio the controller at 2342:54 to suggest a visual approach but interrupted this transmission 1 second later when he stated to the captain, "it's going right over the...field." In a postaccident interview, the first officer indicated that he was referring to a temporary obstruction of his view of the airport because of clouds. The first officer's next transmission, 4 seconds later, informed the controller that "we got the airport" and that "we're going between clouds." Figure 20 shows a map of the weather conditions at 2342:55 and flight 1420's location.

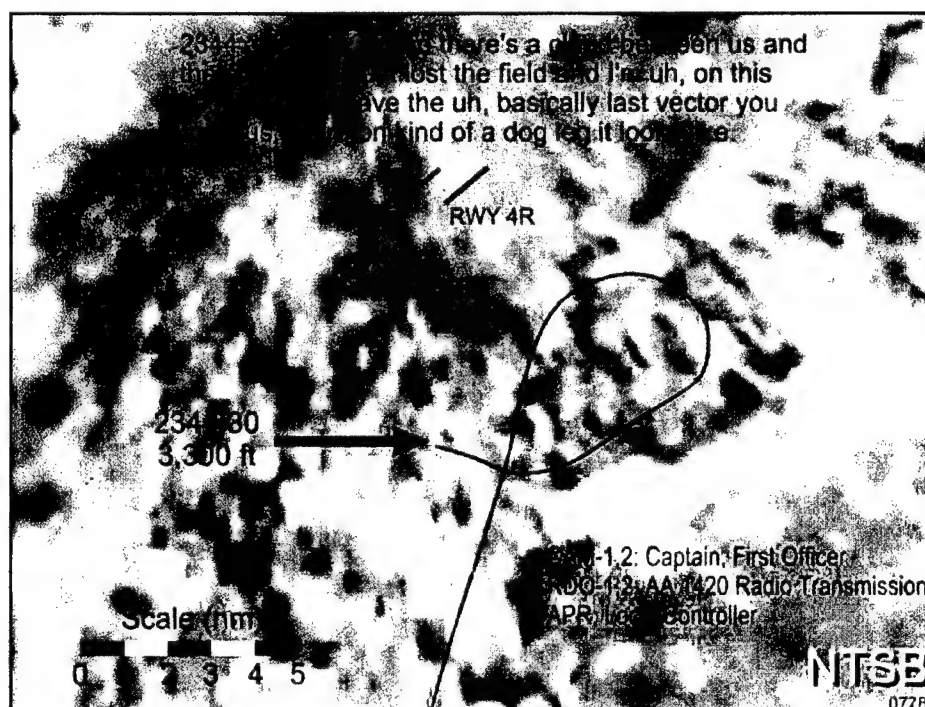
Figure 21. Weather and Flight Information for 2344:30

At 2344:19, the captain stated, "see we're losing it. I don't think we can maintain visual." The first officer notified the controller at 2344:30 that visual contact with the airport had been lost because of a cloud between the airplane and the airport. The controller then cleared the airplane to fly a heading of 220° for radar vectors for the ILS approach to runway 4R. (ATC radar indicated that, at this time, flight 1420 was about 6 miles south of runway 4R, heading westbound and away from the runway. Weather radar data indicated that heavy rain was occurring at the airport at the time that the airplane was flying on the 220° heading.) Figure 21 shows a map of the weather conditions at 2344:30 and flight 1420's location.

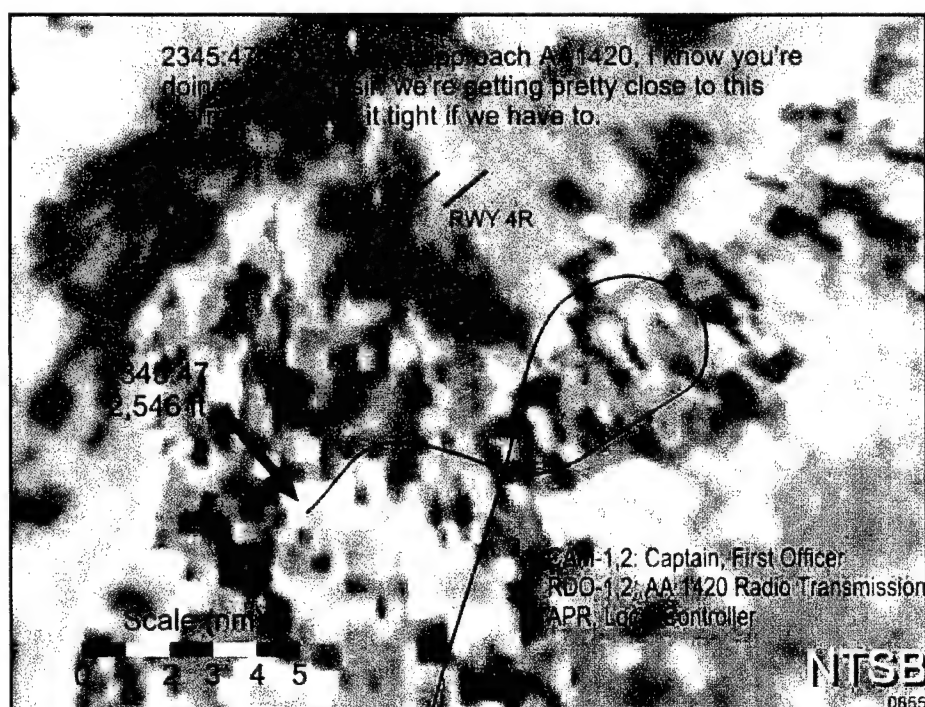
**Figure 22.** Weather and Flight Information for 2345:47

The weather south of the airport became the next focus of the flight crew's attention. NWS radar data indicated that, in the 6 minutes before the accident, a line of thunderstorms, with several large areas of intense and extreme activity, was encompassing the Little Rock airport area and runway 4R approach path. At 2345:47, the first officer told the controller "we're getting pretty close to this storm. we'll keep it tight if we have to." The controller indicated to the flight crew that, "when you join the final, you're going to be right at just a little bit outside the marker if that's gonna be okay for ya." The captain stated, "that's great," and the first officer told the controller, "that's great with us." Figure 22 shows a map of the weather conditions at 2345:47 and flight 1420's location.

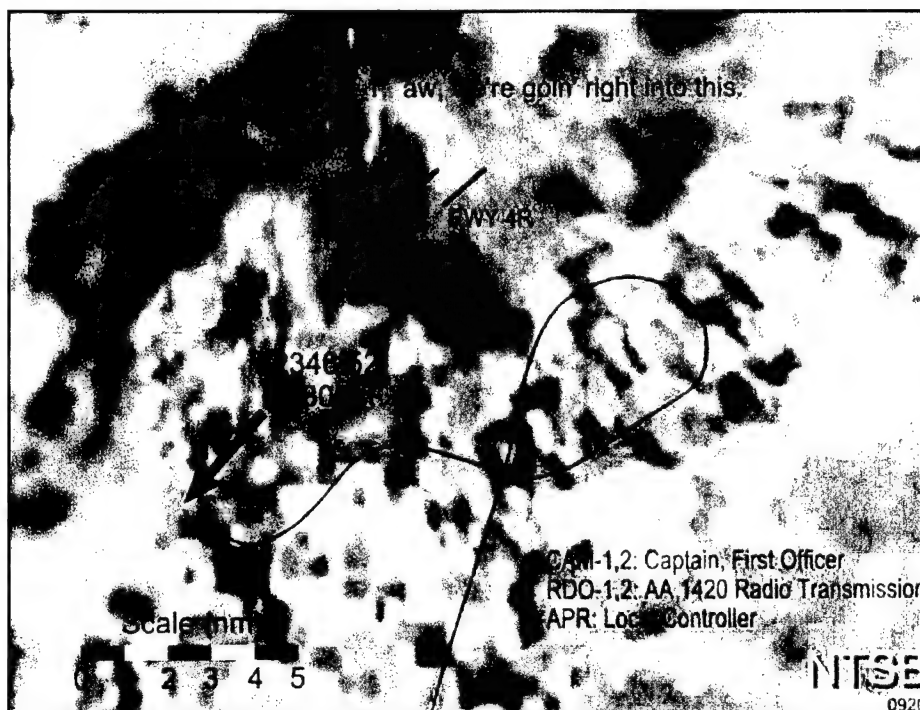
**Figure 23.** Weather and Flight Information for 2346:52

At 2346:52, the controller advised the flight crew that heavy rain was falling at the airport, visibility was less than 1 mile, ATIS information Romeo was no longer current, and the runway visual range (RVR) was 3,000 feet. Simultaneously, the captain stated, "aw, we're goin' right into this." Figure 23 shows a map of the weather conditions at

2346:52 and flight 1420's location. About this point in the approach, the flight crew should have regained the use of the airborne weather radar to depict precipitation levels in front of the airplane. However, the Safety Board could not determine whether the radar was displaying this information or whether the flight crewmembers, given their workload, were able to perceive and interpret the information that the radar was providing.

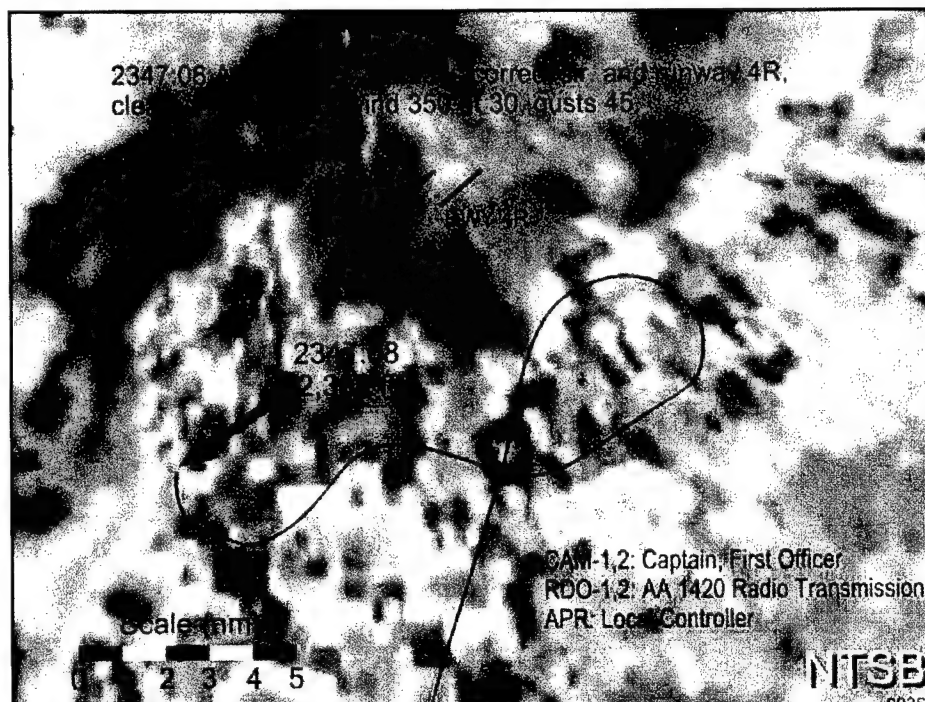
Figure 24. Weather and Flight Information for 2347:08

At 2347:08, the controller cleared flight 1420 to land and stated that the wind was 350° at 30 knots gusting to 45 knots. The CVR indicated that flight crew did not discuss the wind information, the heavy rain that was already falling at the airport, or the depiction of the weather on the airborne weather radar. Figure 24 shows a map of the weather conditions at 2347:08 and flight 1420's location.

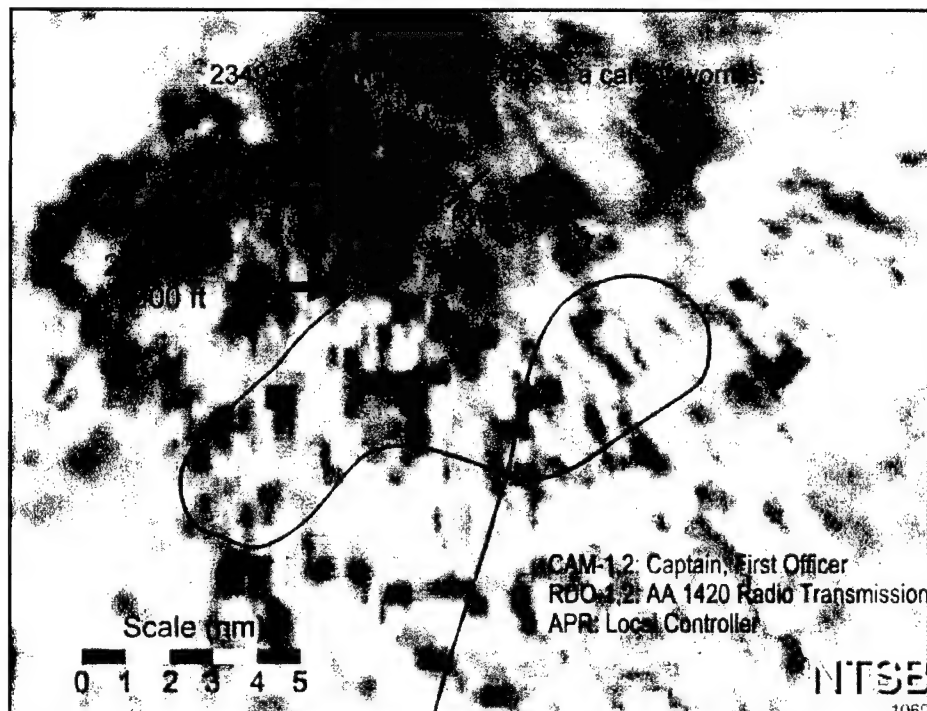
**Figure 25.** Weather and Flight Information for 2349:12

At 2349:10, the controller indicated that the winds were 330° at 28 knots. About 2 seconds later, the captain stated, "...this is a can of worms." FDR data indicated that the airplane was about 1,140 feet msl (880 feet afl) at this time and that the captain was making active control inputs to keep the airplane on the localizer and glideslope. Also, the FDR data showing fluctuating airspeed ( $\pm 5$  knots, with one excursion to +8 knots and one to -10 knots) and vertical acceleration ( $\pm 0.2$  G with occasional excursions to  $\pm 0.25$  G)<sup>186</sup> were consistent with the presence of gusty and turbulent winds. Figure 25 shows a map of the weather conditions at 2349:12 and flight 1420's location.

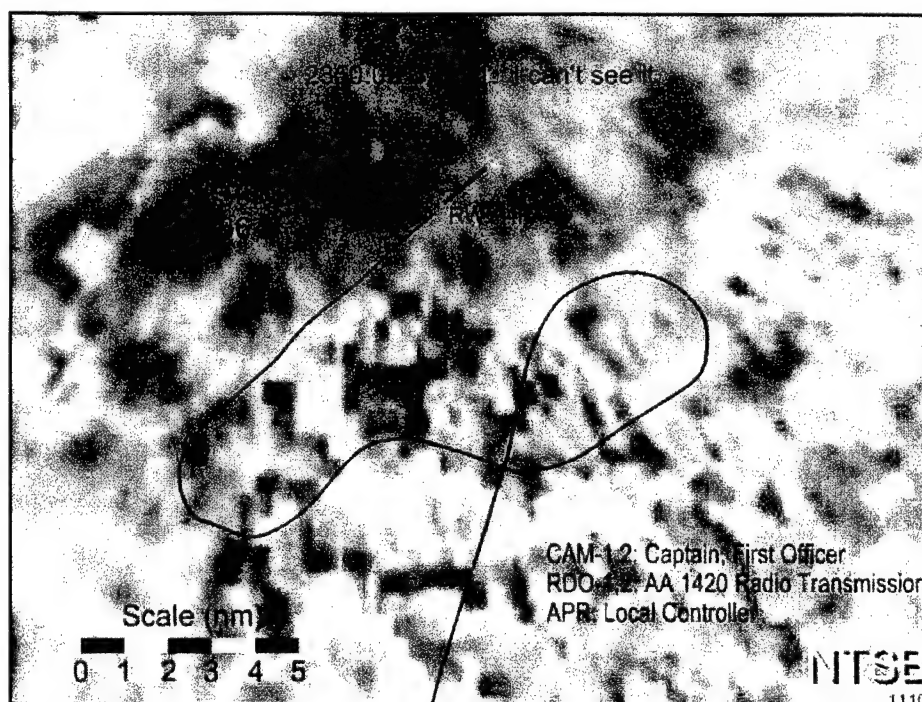
**Figure 26.** Weather and Flight Information for 2350:02

At 2350:02, the captain stated, "I can't see it." Calculations based on FDR data indicated that the airplane was between 5 and 20 feet above the decision height at that time. The Safety Board was not able to determine whether the captain's comment referred to his loss of visual contact with the runway or with its environment. Figure 26 shows a map of the weather conditions at 2350:02 and flight 1420's location.
